CONFIDENTIAL INSPECTION REPORT

427 Any Street, Harleysville, PA 19438

2/26/2009 9:00 am to 11:00 am

Structure Style: Condominium

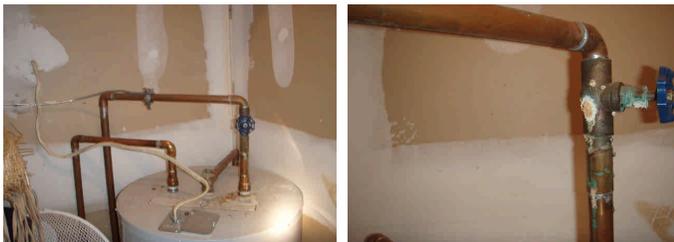
There is a leaking shutoff valve above the water heater. A plumber should replace this valve.

- There is a leaking shutoff valve above the water heater. A plumber should replace this valve.
